# **Natural Sciences Existing Conditions and Preliminary Impact Assessment Report**

## **Preliminary Design and Environmental Assessment**

**Highway 401 Power Dam Bridge**

**Ministry of Transportation, Eastern Region**

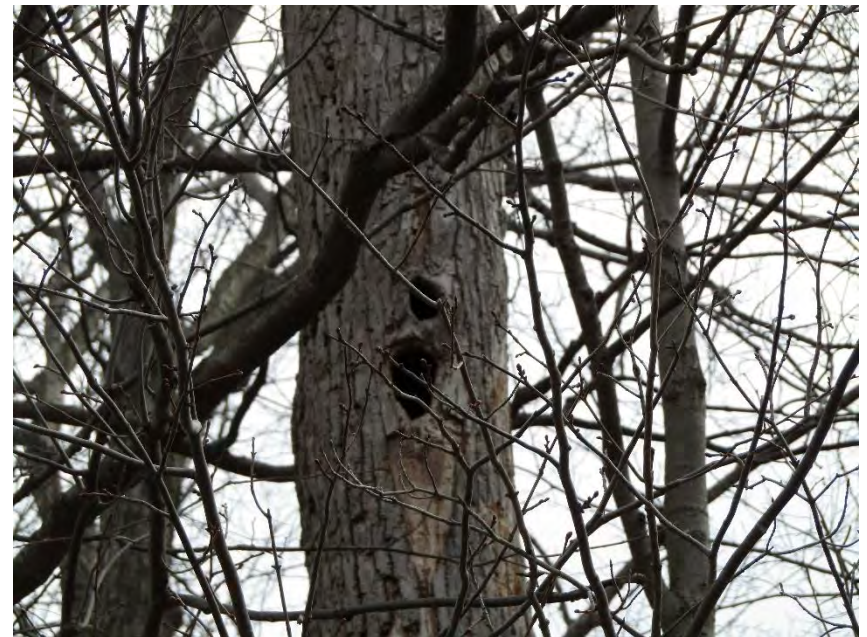
**Photo 4.** Example of candidate bat cavity tree (see woodpecker holes) within FODM6 community. April 21, 2022.

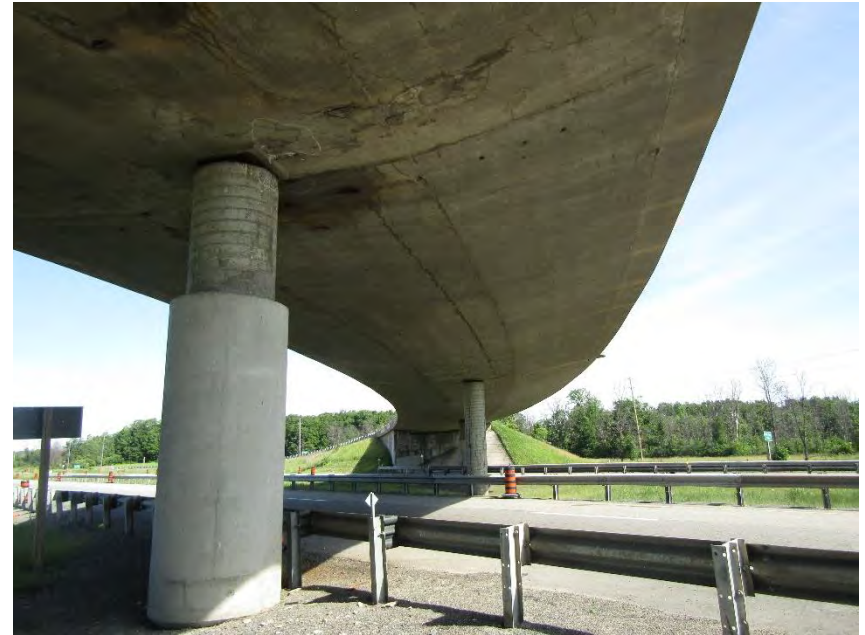
**Photo 10.** Power Dam Drive overpass – no Barn Swallow nests. June 15, 2022.

Three (3) Barn Swallow (*Hirundo rustica*), designated as Special Concern under the ESA, were observed during the 2022 breeding bird surveys; one (1) at BBS 19 on June 15, 2022, and two (2) at BBS 17 on June 23, 2022. These individuals were observed during breeding season within suitable nesting habitat. No nests were identified under the Power Dam Drive overpass.

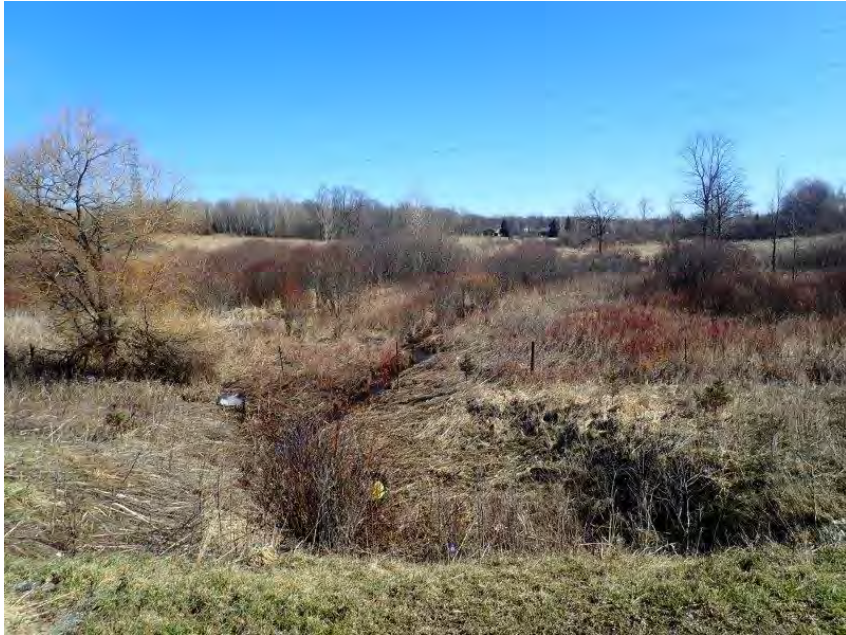
**Photo 1.** Culvert 2 (C2) – Highway 401 – Overview of the culvert inlet and upstream channel. April 11, 2022

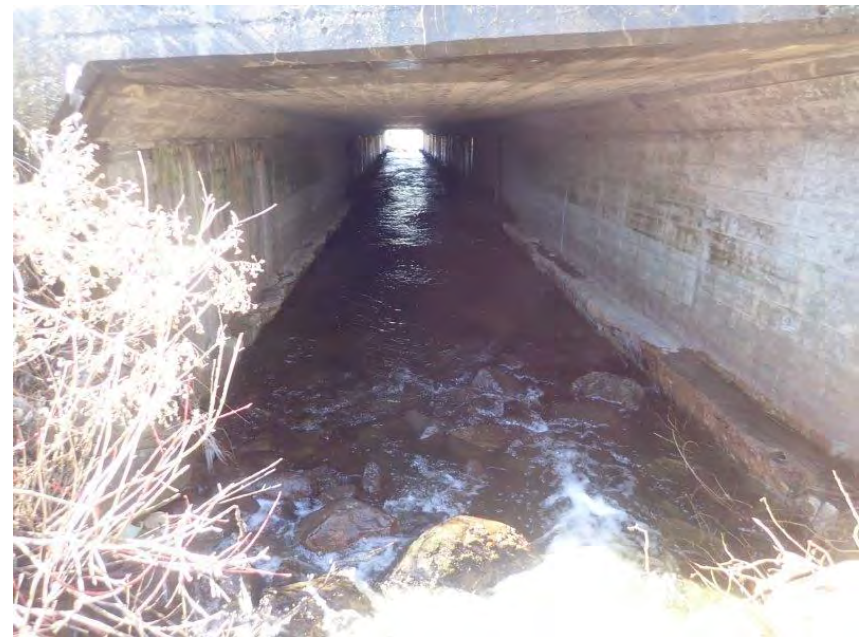
**Photo 4.** C2 – Highway 401 – View inside culvert inlet from upstream side. April 11, 2022

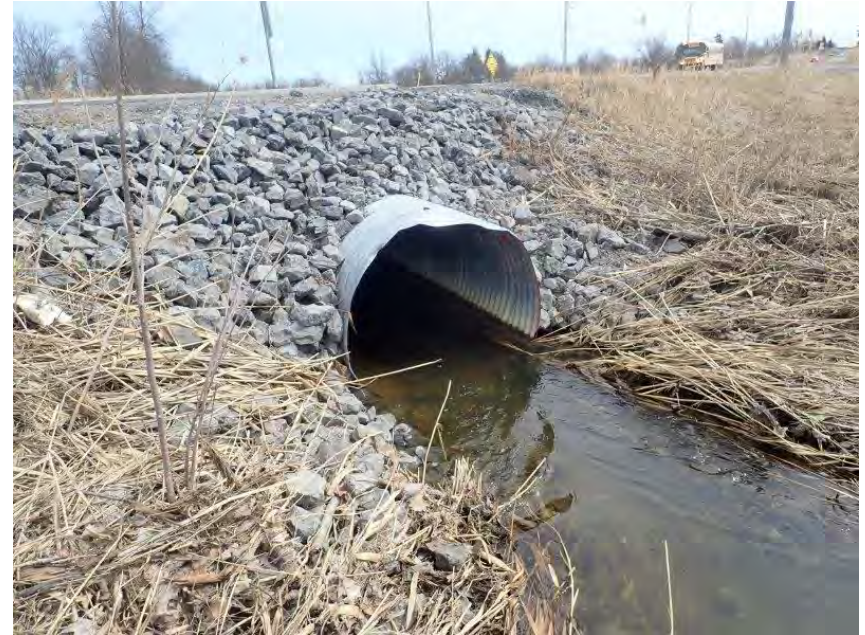
**Photo 14.** C17 – Power Dam Drive – View of the culvert inlet. April 11, 2022

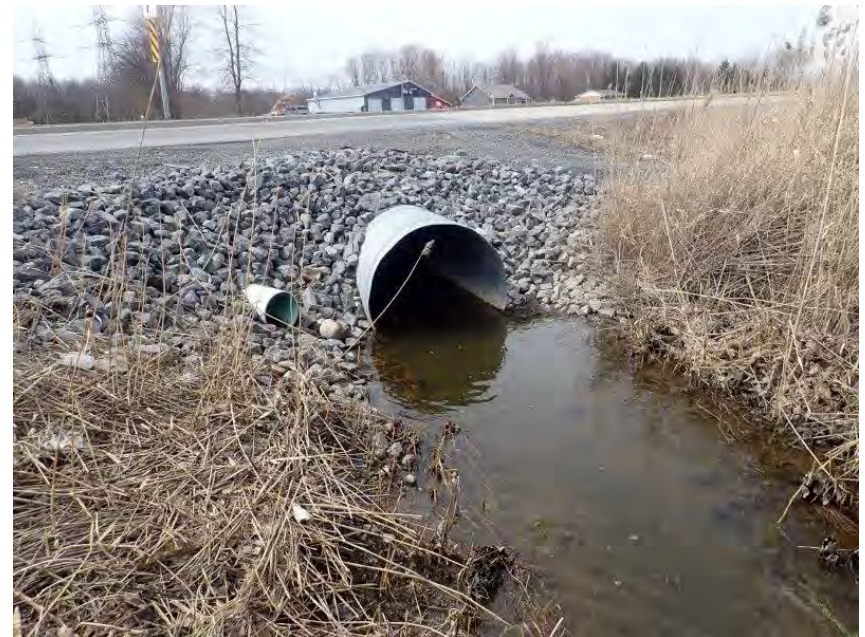
**Photo 16.** C17 – Power Dam Drive – View of the culvert outlet. April 11, 2022

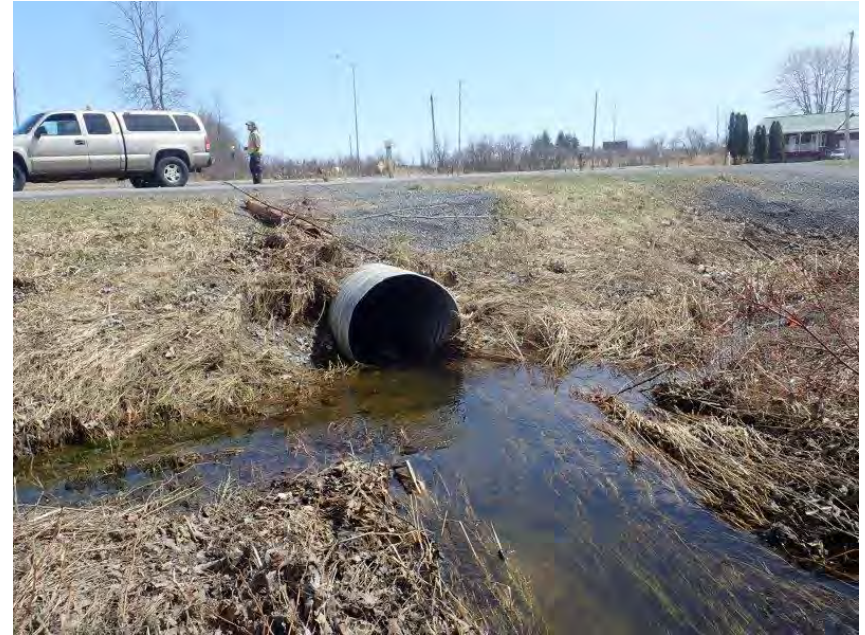
**Photo 22.** C18 – Atchison Road – View of the culvert inlet. April 11, 2022

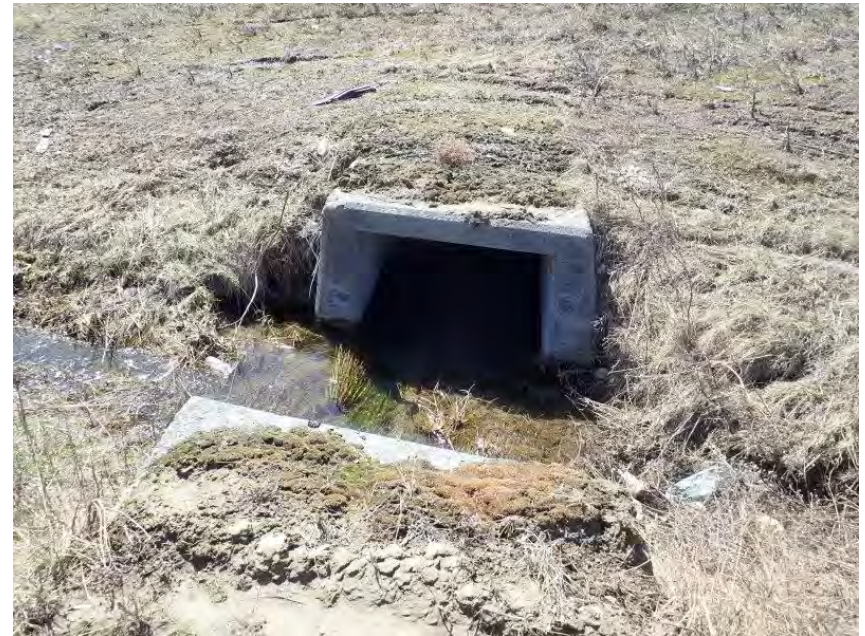
**Photo 32.** C22 and C23 – Hwy 401 (Median) – View of the inlet (C22) and outlet (C23) at the median. April 11, 2022

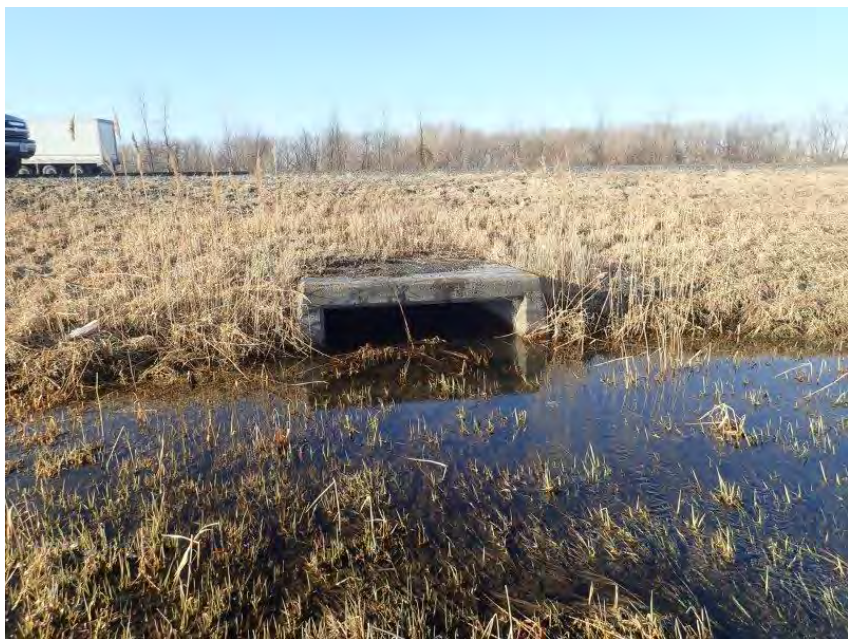
**Photo 39.** C25 – Highway 401 – View of the culvert inlet with flooded ditchline. April 11, 2022

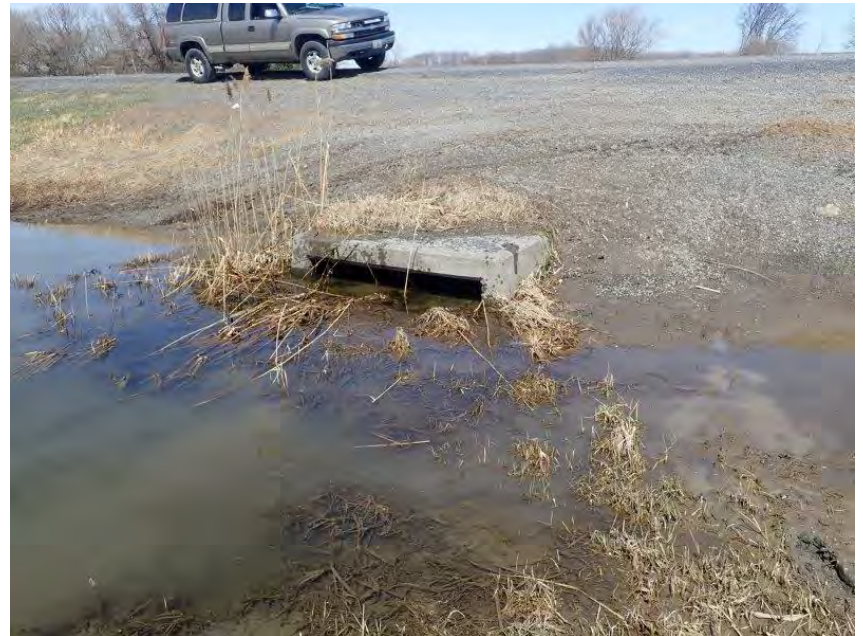
**Photo 42.** C25 – Highway 401 – View of culvert outlet, downstream area and standing water in ditchline. April 11, 2022
