Appendix I – Highway 401 and Power Dam Drive Interchange Environmental Noise Assessment

HIGHWAY 401 AND POWER DAM DRIVE INTERCHANGE

CORNWALL, ONTARIO

ENVIRONMENTAL NOISE ASSESSMENT RWDI #2104052/ MTO WORK ORDER4017-E-0023 June 28, 2024

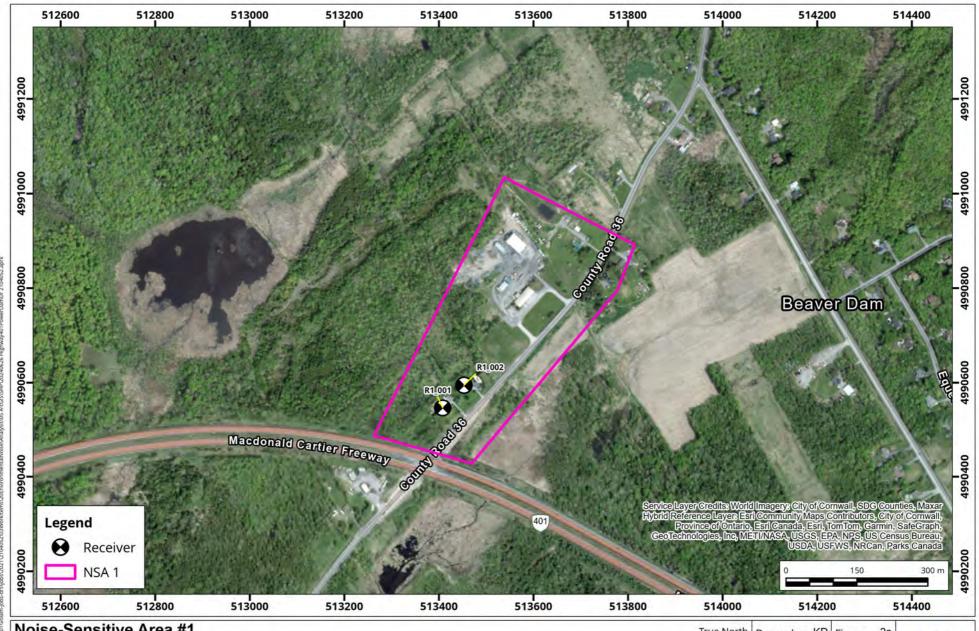
Noise-Sensitive Area #1
Locations of Noise-Sensitive Receivers

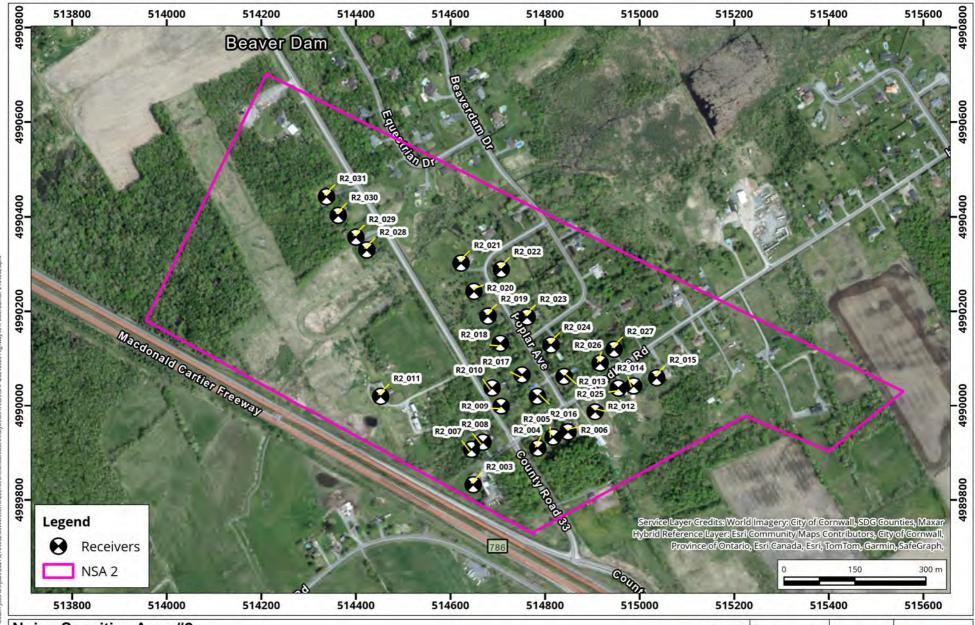
Noise-Sensitive Area #2
Locations of Noise-Sensitive Receivers

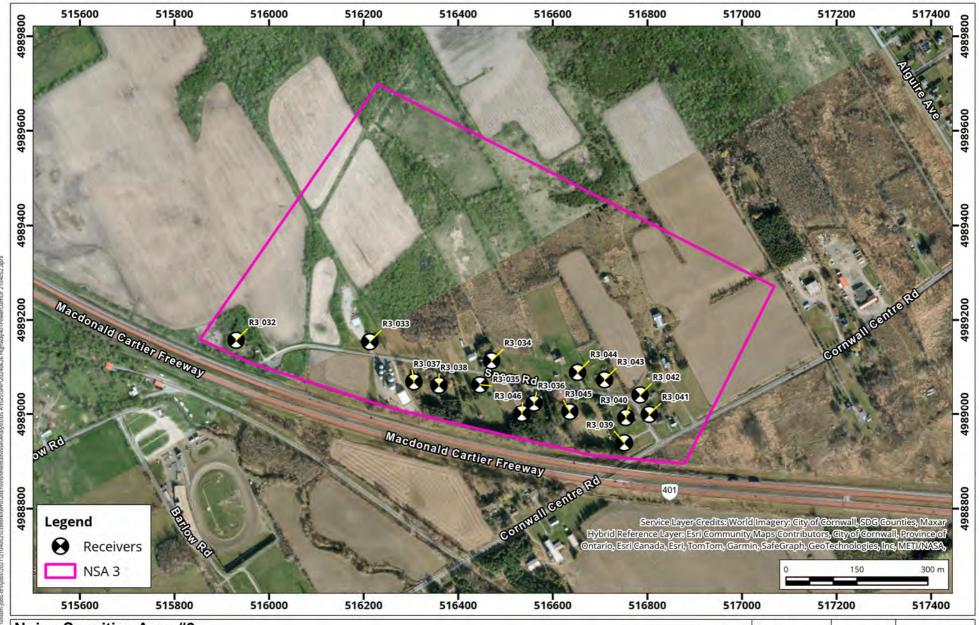
Noise-Sensitive Area #3 **Locations of Noise-Sensitive Receivers**

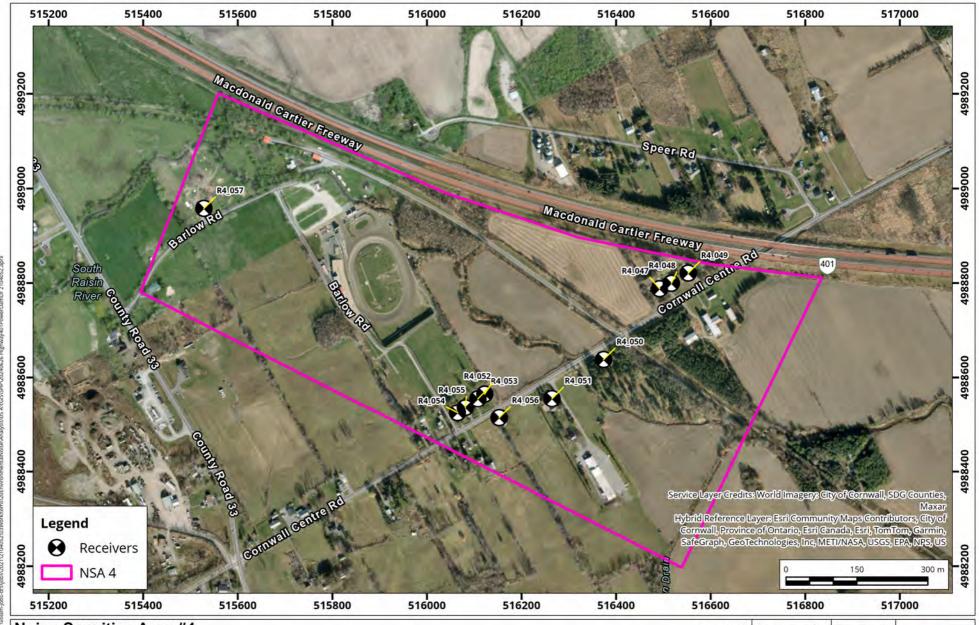
Noise-Sensitive Area #4 **Locations of Noise-Sensitive Receivers**

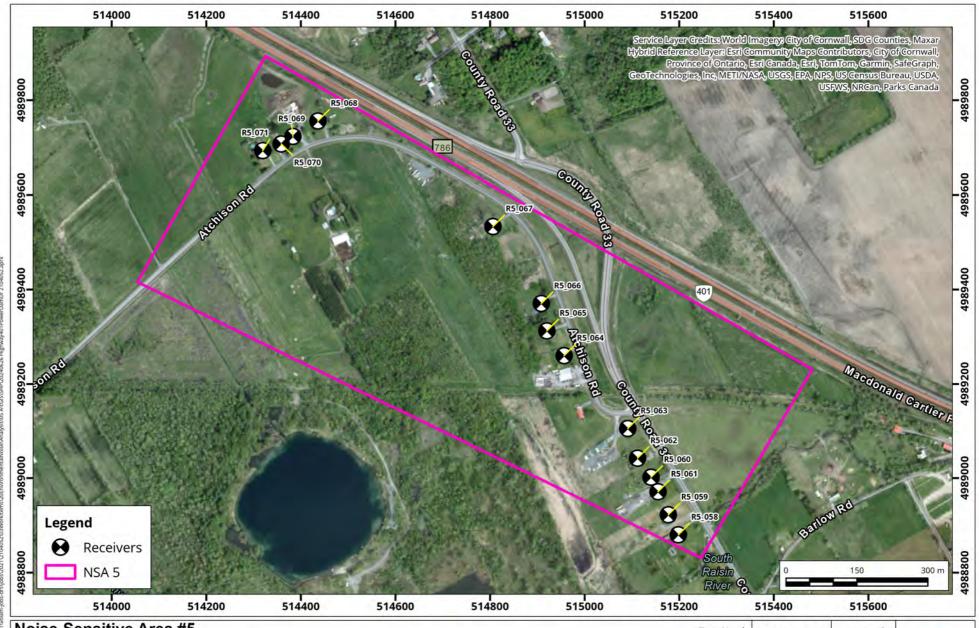
Noise-Sensitive Area #5
Locations of Noise-Sensitive Receivers

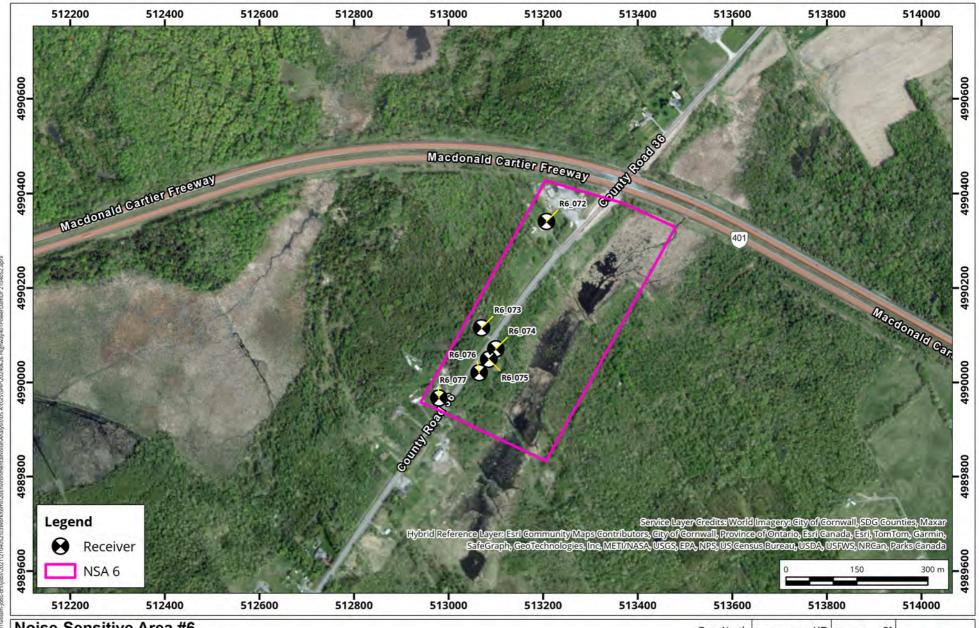
Noise-Sensitive Area #6
Locations of Noise-Sensitive Receivers

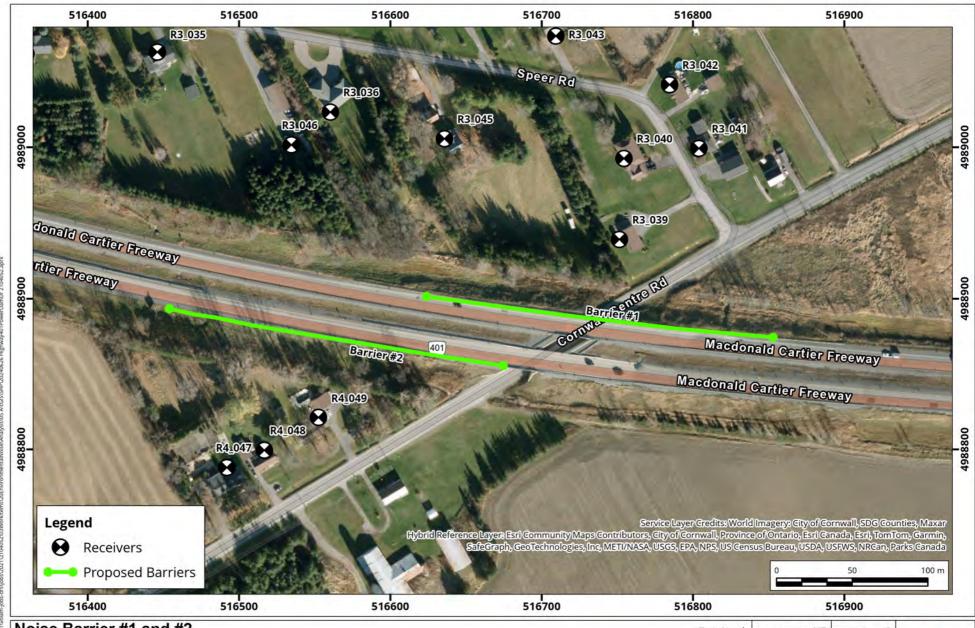
Noise Barrier #1 and #2 **Locations of Noise Barriers**

The relative increase in the future sound levels as a result of the undertaking as compared with the no-built scenario did not trigger the 5 dBA criteria. Noise mitigation was investigated because the future sound levels attributed to Highway 401 exceeded 65 dBA at two receivers. However, the proposed noise barriers are not economically feasible, thus not recommended.

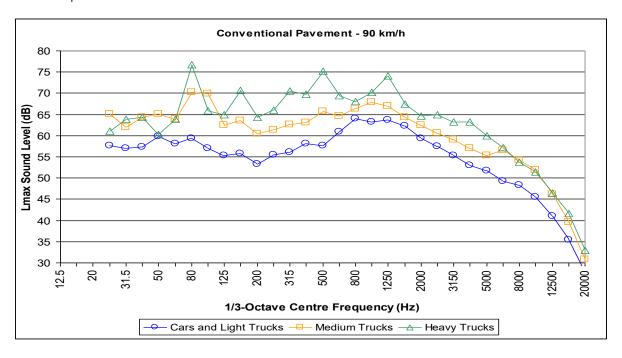
Figure 1: Typical Frequency Spectra of Traffic Noise - Vehicle Pass-bys at 90 km/h

Sound is typically analysed in octave bands or 1/3-octave bands. An octave band is defined as a band or range of sound frequencies where the frequency range doubles for succeeding octave (alternately, the highest frequency in the range is twice the value of the lowest frequency). Octave band and 1/3-octave band frequencies of interest frequencies of interest are shown in the table on the following page. Road and rail transportation noise sources tend to be broadband in nature, having roughly equal sound energy in many octave bands. Heavy rail traffic and heavy truck traffic may produce significant noise in lower frequencies < 200 Hz.

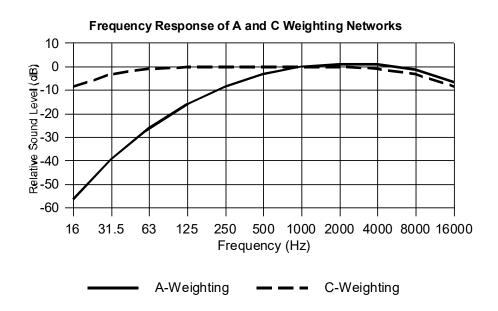
Figure 2: A-Weighting and C-Weighting Networks

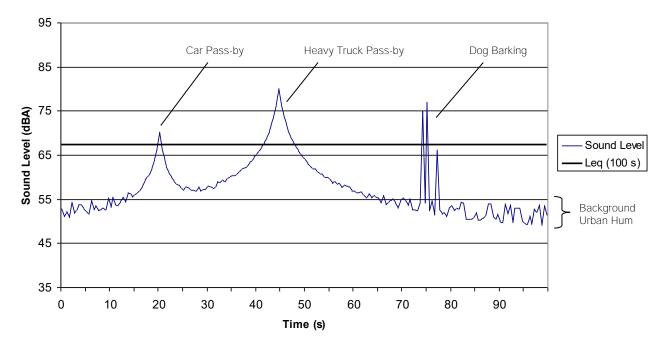
Figure 3: Example of the Leq Concept

In this example, the background "urban hum" is between 47 and 53 dBA. A car passes by at 20 seconds. As it approaches, the noise level increases to a maximum, and then decreases as it speeds away. At 45 seconds, a heavy truck passes by. Near 75 seconds, a dog barks three times. The maximum sound level (L_{max}) over the period is 80 dBA and the minimum is 47 dBA. For almost 50% of the time, the sound level is lower than 55 dBA.

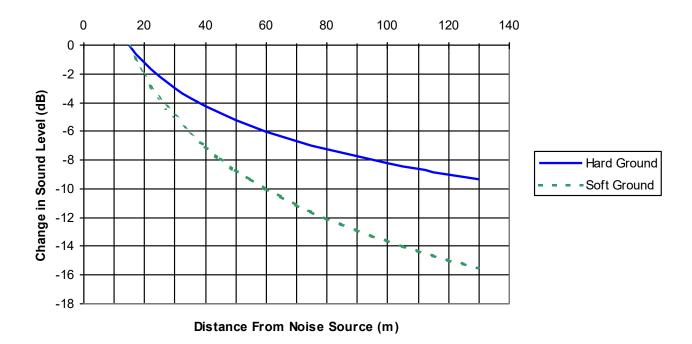
Figure 4: Decay of Noise Versus Distance for Line Sources

Noise levels decrease with increasing distance from a source of noise. The rate of decay is partially dependent on the nature of the ground between the source: whether it is hard (acoustically reflective) or soft (acoustically absorptive). Transportation noise sources in general act as *line sources* of sound. For line sources, the rate of decay is approximately:

• Soft ground: 5 dB for each doubling of distance from the source

This is shown graphically in Figure 6, based on a reference distance of 15 m from the source:

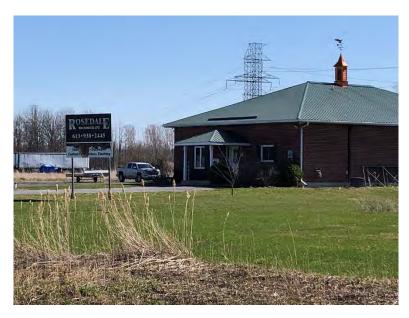
Photo #1 Rosedale Mechanical

| PCA | Location | Description | Risk Rating |
|--|---|--|---|
| PCA #34: Metal Fabrication | Off-Site 16900 Atchison Road | Rosedale Mechanical is a facility involved in sheet metal work, custom fabrication, and steel sales. This facility was observed during the site visit. | |

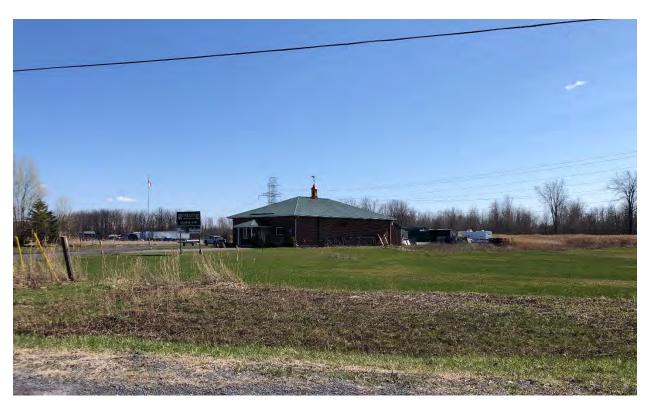
Photo #2 Rosedale Mechanical

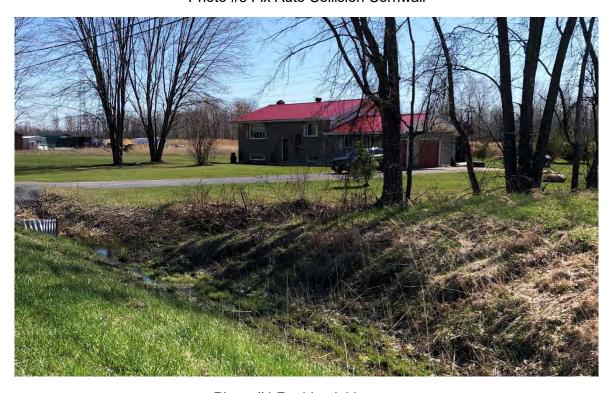
Photo #4 Residential houses and roadside ditches

There are no water bodies within the study area. Drainage on the roads and surrounding areas are collected by roadside ditches and drains. No catch basins or manhole covers were observed in the study area during site reconnaissance.
